UNDERWATER BRIDGE INSPECTION REPORT

STRUCTURE NO. 24514

SHELL ROCK CHANNEL

DISTRICT 6 - FREEBORN COUNTY, CITY OF ALBERT LEA

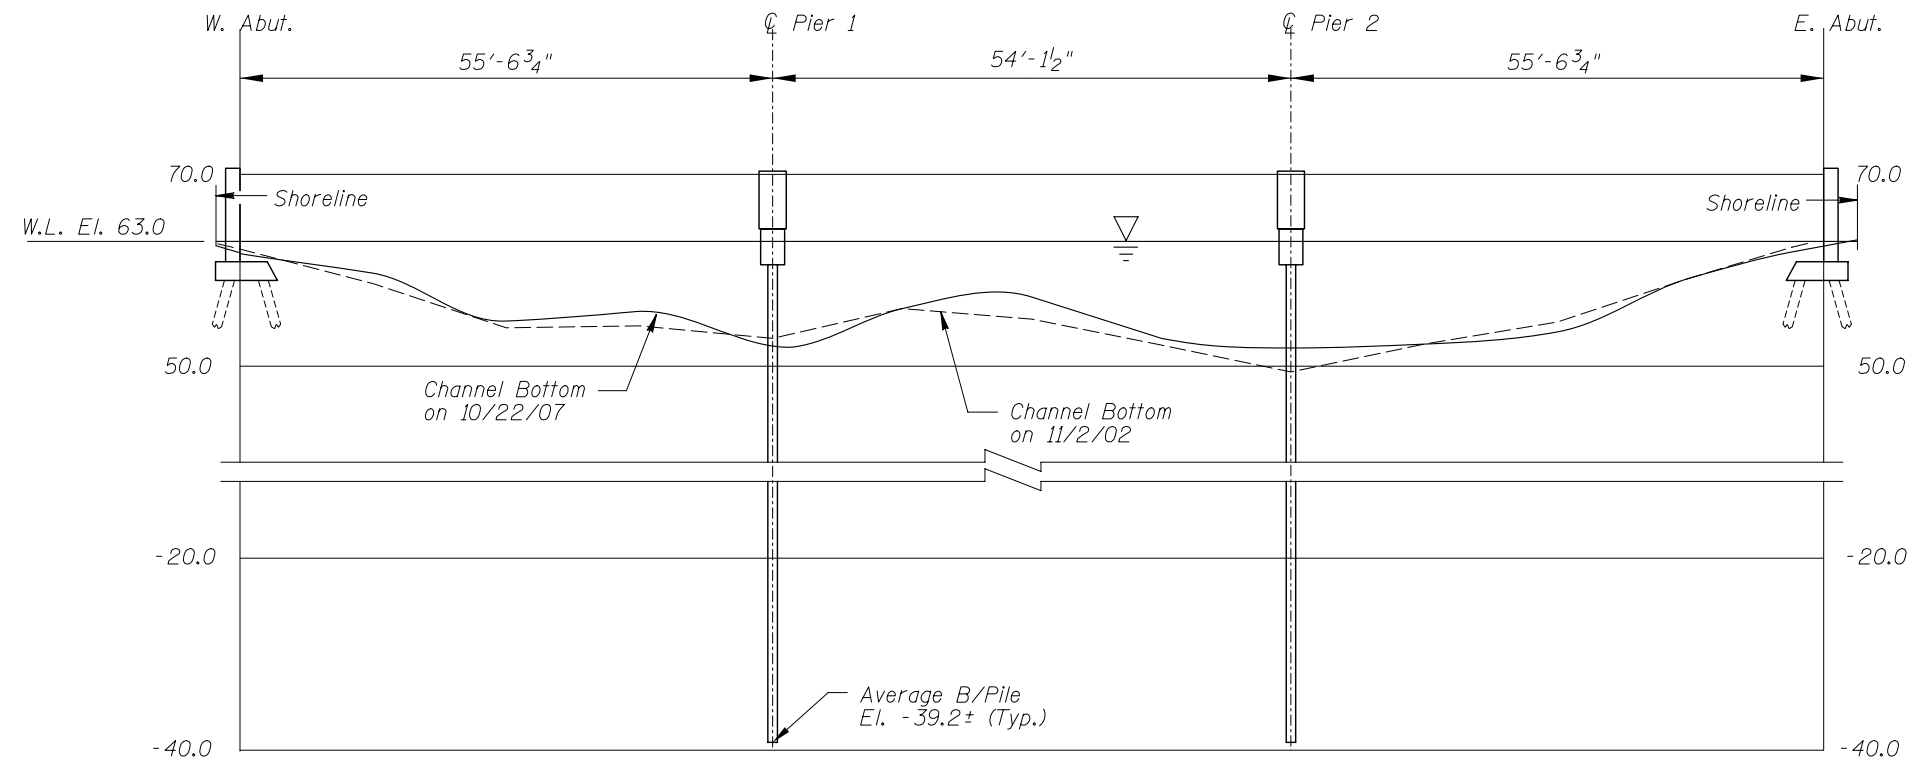
UPSTREAM FASCIA PROFILE

3. Overall, the concrete abutments were in smooth and sound condition with no structurally significant defects observed.
4. The steel H-piles exhibited 100 percent coating failure with moderate surface corrosion with up to 1-inch-diameter rust nodules and 1/32-inch-deep pitting over approximately 50 percent of the surface area. Majority of nodules were scattered and 1/4 inch diameter in size.

5. The concrete encasements exhibited map cracking and widespread areas of section loss with up to 6 inches of penetration from the waterline to the bottom of the encasement. Frequent areas of exposed reinforcing were also noted.

6. Timber and steel formwork was still in place.
7. A welded splice of steel H-pile was observed 7.5 feet below the waterline and was in good condition.

8. An area of section loss, 2 feet high by 2 feet wide, was observed above the waterline with up to 1 inch of penetration.

The concrete encasements of the steel H-piles have deteriorated to the point where repair is not cost-effective. It should be noted that the encasements are for cosmetic and pile protection reasons, and that overall pier and pile integrity has yet to be adversely affected by the encasement problems. If full protective encasement is considered necessary, encasement replacement would be the appropriate remedial measure.
